Hydrosol System Furnace Cooling Water Cleaning Case Study: North American Stainless

III. Cleaning Process – NAS Reheat Furnace

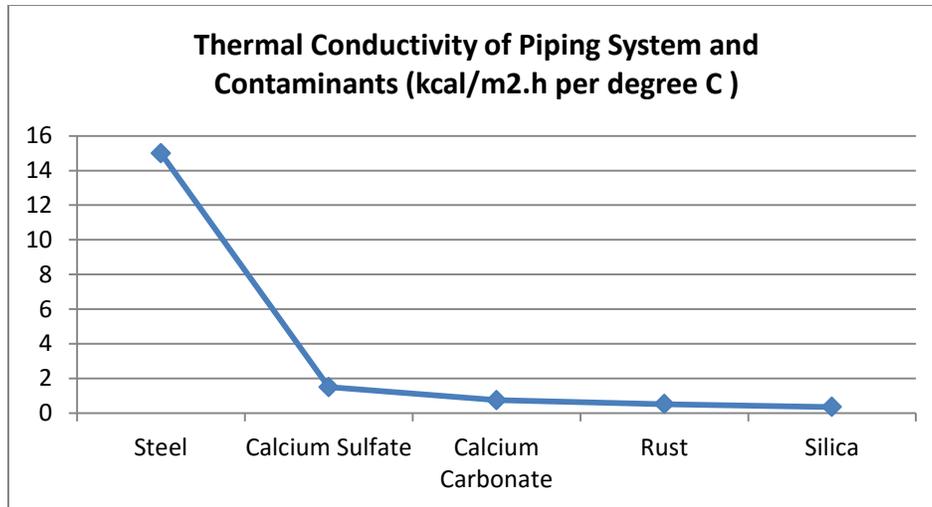
Common contaminants found in the scaling of cooling water systems include calcium, silica, and iron. As these contaminants precipitate they form solid deposits on the piping system walls and insulate the metal surface from the cooling water, restricting heat transfer and fluid flow. Common compositions and thermal conductivities alongside that of the Steel base metal are shown in Table 1.

Figure 1: Thermal conductivity of steel and water contaminant buildups

Heat exchanging systems are critical components in many manufacturing industries and require consistent monitoring and maintenance to preserve their thermal efficiencies which will result in avoided downtime and costly repairs. Contaminant buildup has a major impact on cooling efficiency as shown in Figure 1 and is resultant of either corrosion in the system or from contaminants in the cooling media itself both of which bond to the walls of the piping in the cooling system. The subject of scale buildup is complex and the type of scaling is unique to each system requiring trained chemical cleaning technicians to evaluate each system for development of a specific cleaning process and schedule. With proper maintenance, your most critical assets can be protected for decades of high performance and peace of mind.

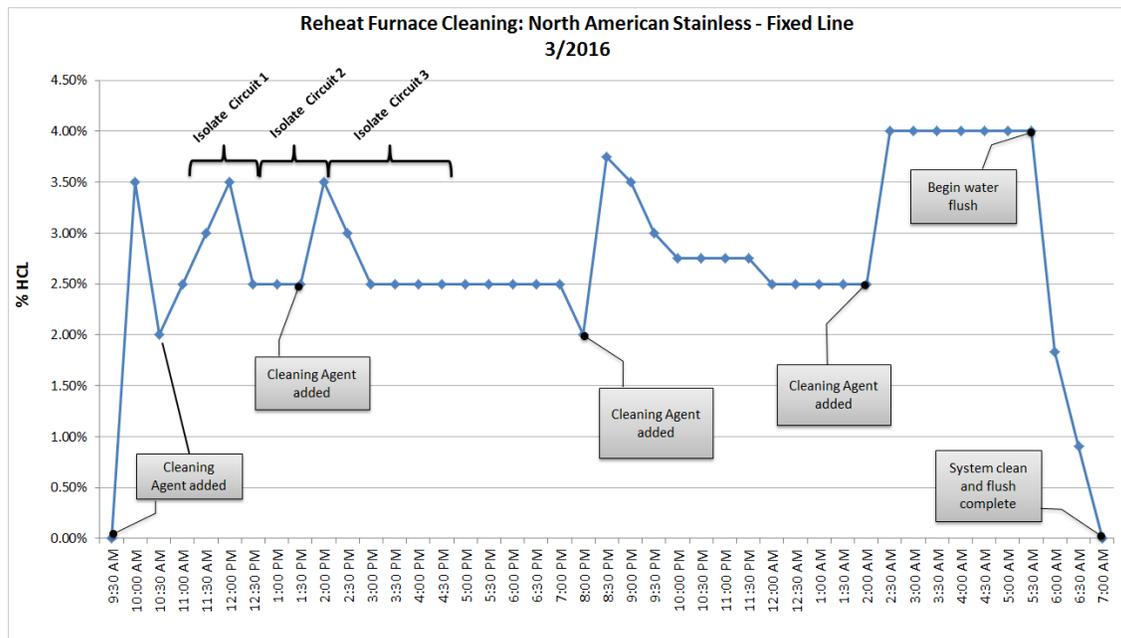
Phase one of the cleaning process is the circulation of water and inspection of the entire piping system to ensure no leaks exist. Upon successful inspection of cooling water system, Phase two begins with injection of Hydrochloric Acid (HCL) with corrosion inhibitor added to protect the system from corrosion. The inhibited HCL is circulated in the system and begins removal of scaling. Hydrosol System technicians closely monitors the ratio of HCL within the system by performing on-site testing. As the HCL removes scaling it either becomes tied up within cleaning solution or heavy particles fall into the baffled cleaning tank. This results in rises and falls in the ration of HCL in the cleaning solution. Circulation continued around the clock until a level of equilibrium is attained for an extended period of flushing time, this indicates scaling is no longer being removed from the pipe system and therefore an acceptable level of cleanliness has been achieved. An example graph of this cleaning cycle is observed in Figure 2.

Figure 2: Graph of cleaning process for Cooling Water System, NAS
